## Case Study

### ***Inspection of Inter Cooler Tubes in MEG Plant using Eddy Current Technique at one of the Petrochemical Company in India***

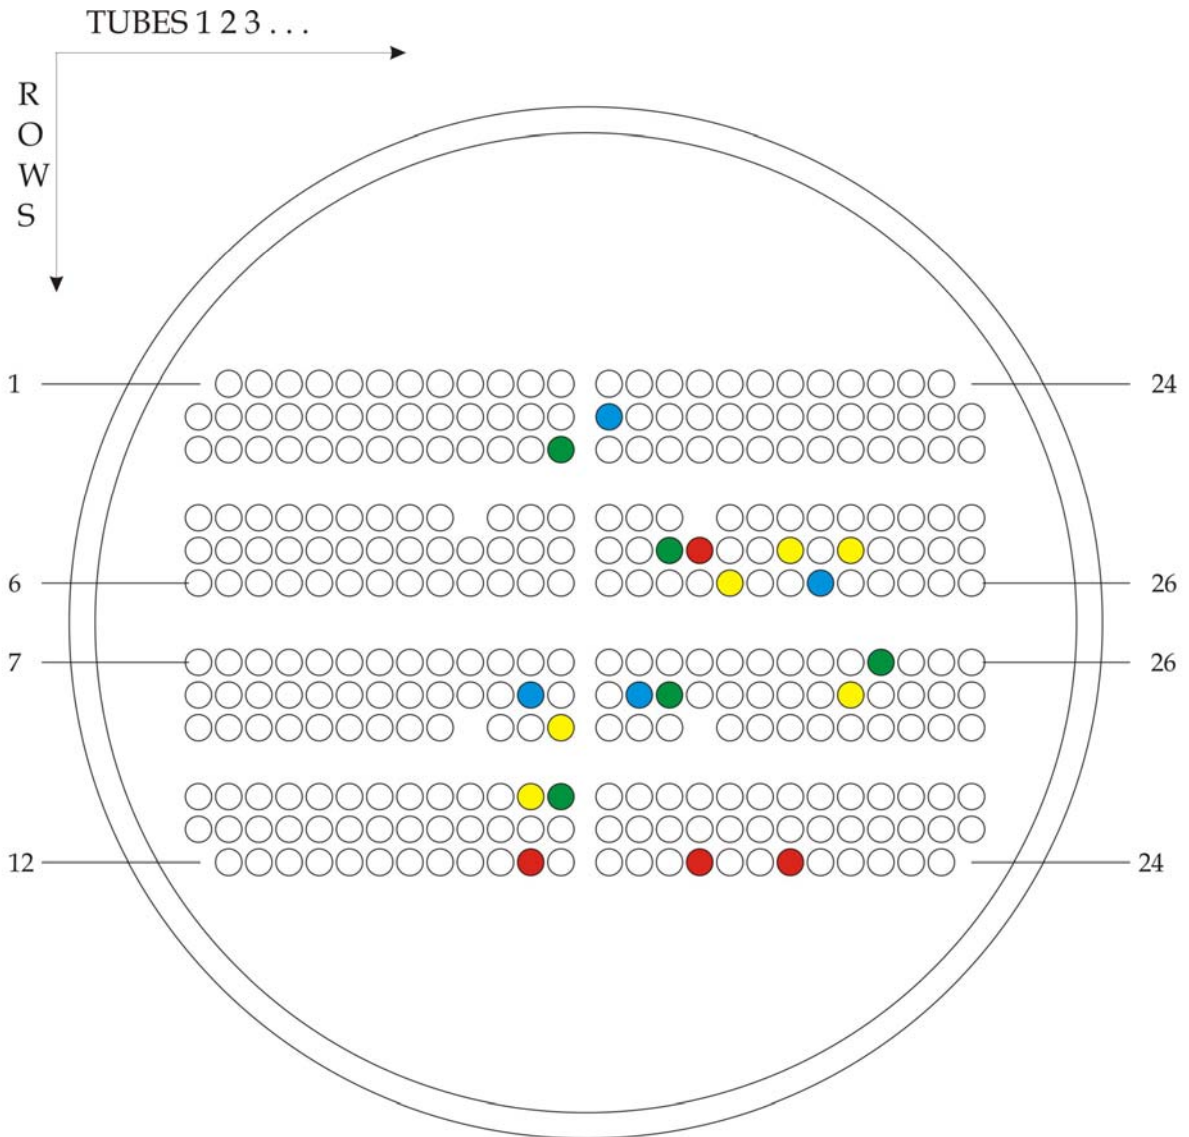
## Color Coded Tube Sheet layout of one of the Inter Cooler

On inspection it was observed that 83 numbers of tubes were showing Baffle Fretting type defects.

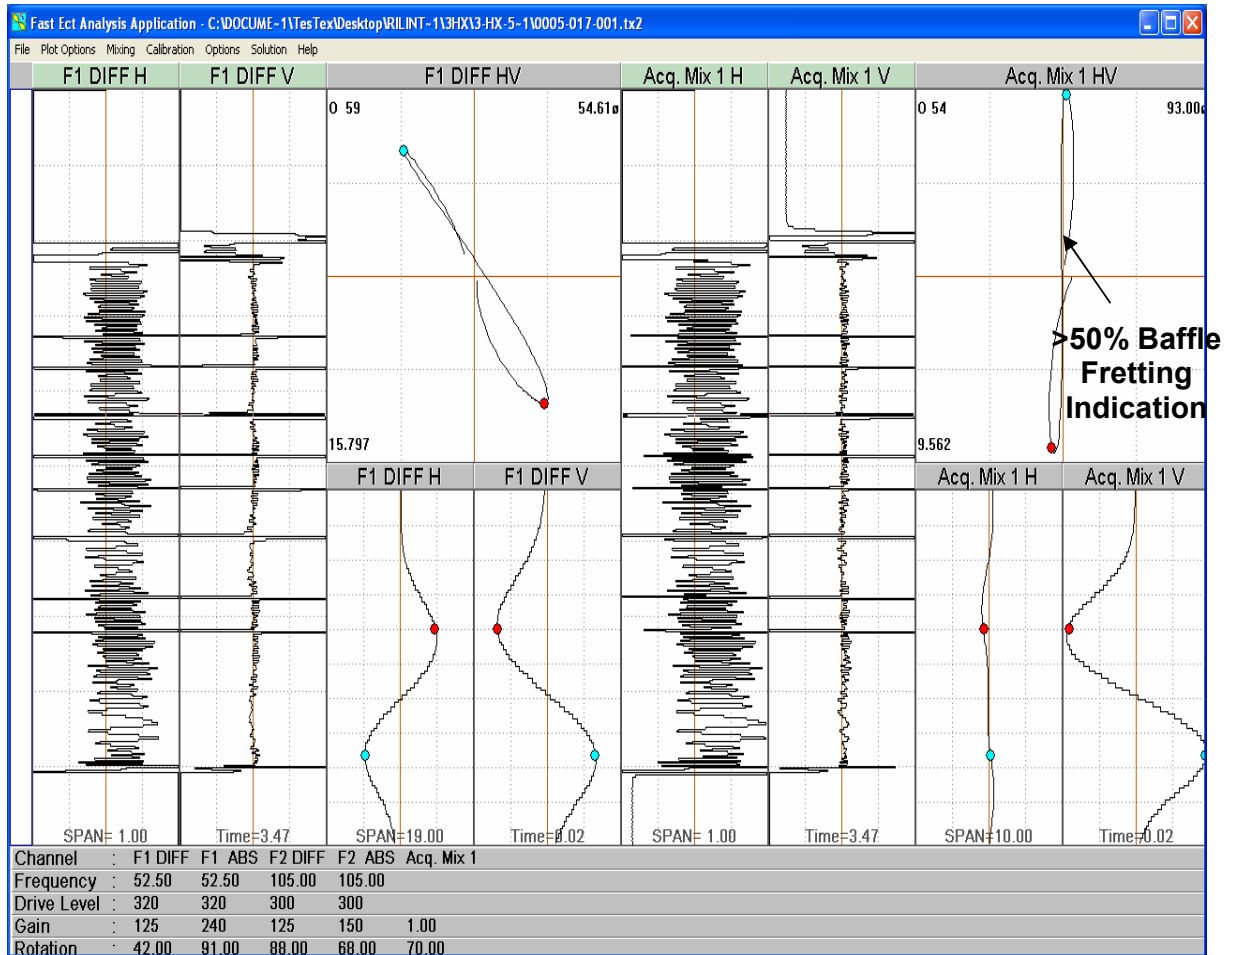
Above waveform from Row # 5 Tube # 17 showing baffle fretting like indication >50% with reference to calibration standard.

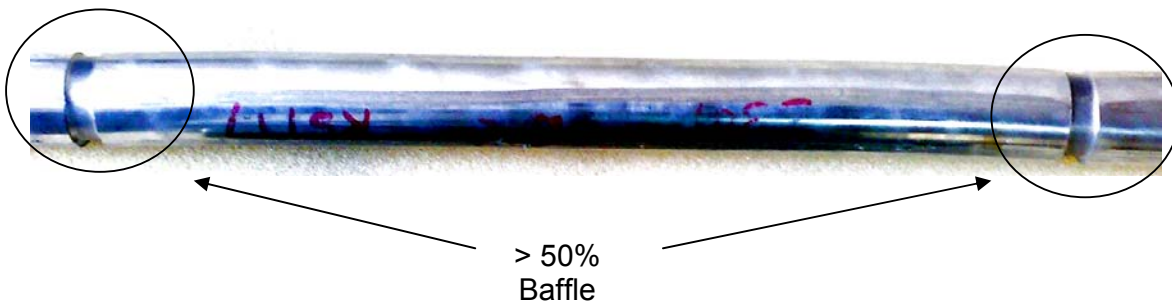
All the 83 tubes were pulled out for verification and severe Baffle Fretting damage was observed on all the tubes. Few tubes which were not showing any flow indications during inspection were also pulled out for verification and no defects were observed on those tubes.

Actual Tube from Row # 5 Tube # 17 showing Baffle Fretting

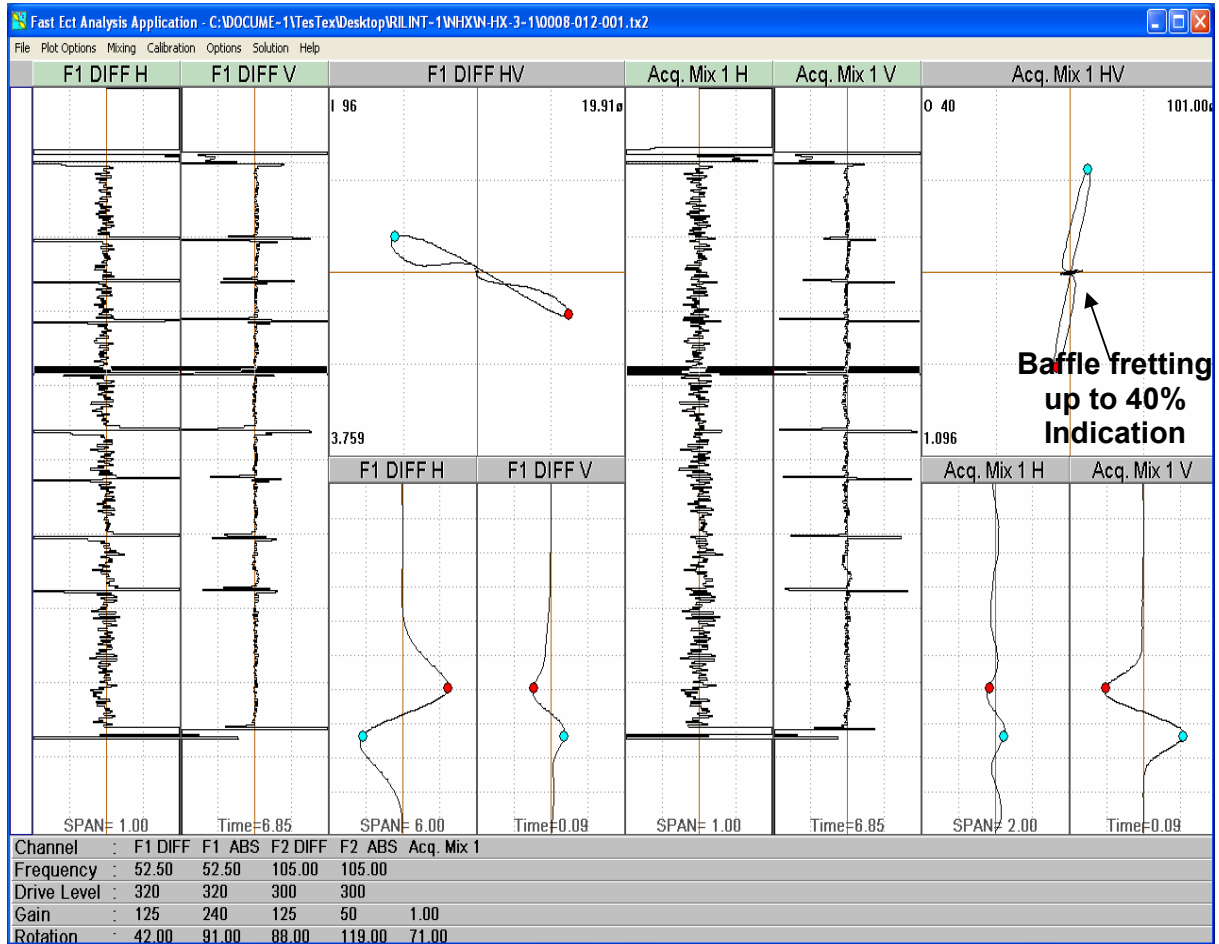
Above waveform from Row # 8 Tube # 12 showing baffle fretting like indication up to 40% with reference to calibration standard.

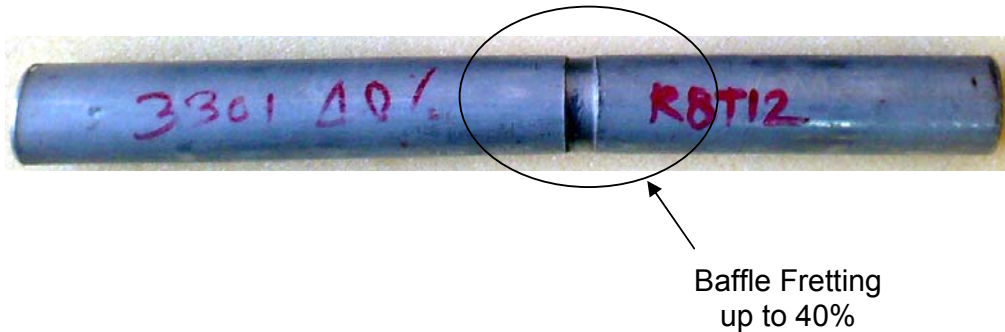
Actual Tube from showing Baffle Fretting
