## Case Study

### Above Ground Storage Tank Floor Plates Scanning using Low Frequency Electromagnetic Technique (LFET)

Above Ground Storage Tank Floor Plate Scanning work was carried out by **TestTex** using **Low Frequency Electromagnetic Inspection** in December 2010 in one of the Refinery Tank Farm and the same tank was again inspected in November 2014 with **TestTex make Falcon Mark-II System** to detect, locate and measure the extent of corrosion and pitting from top side as well as under side, if any in the tank plates.

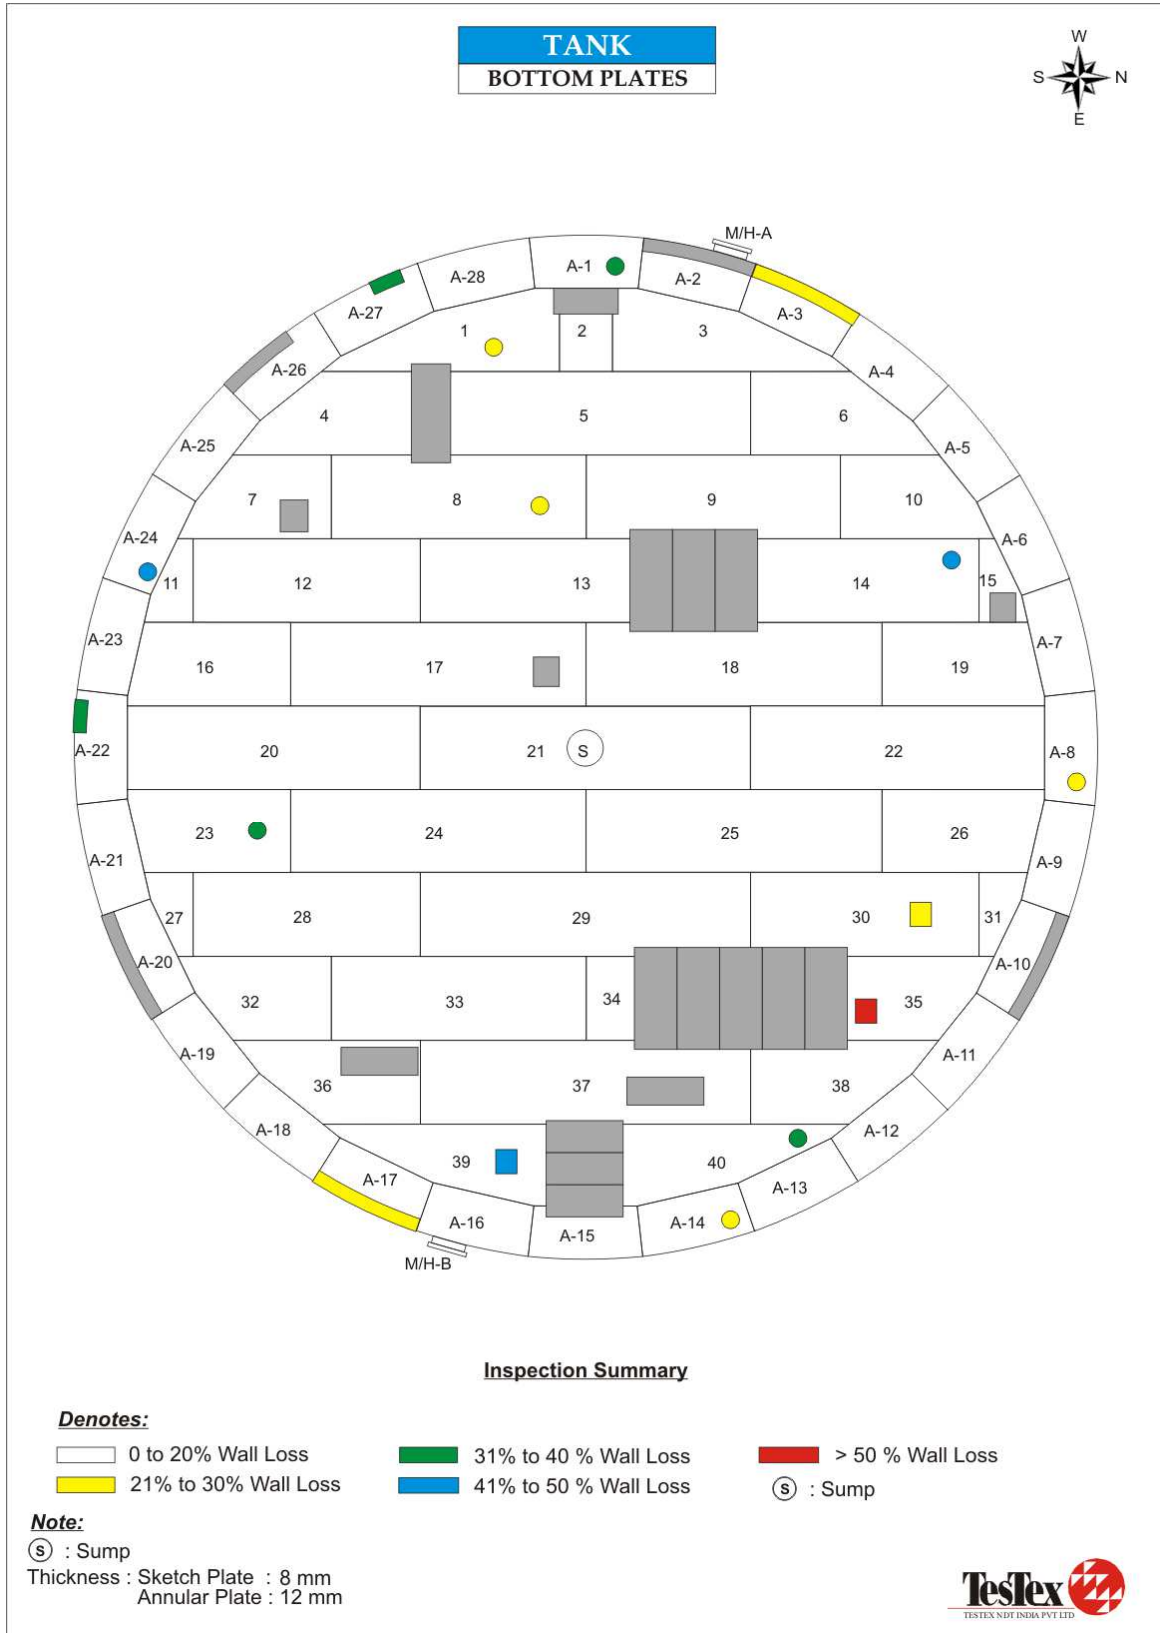
# Color Coded Tank Bottom Plate layout (Inspected in 2014)

Tank was offered for scanning and **Low Frequency Electromagnetic Technique** was used. On scanning severe under side (soil side) corrosion patches were detected on the North-East side of the tank. Further investigation confirmed tiny holes which were extending from the corrosion patches. Few of the annular plates were also affected as shown in the above sketch.

After years of service tank was once again suspecting leakage. Once again visual inspection did not confirm the areas of leakage. Scanning activity was undertaken. Surprisingly this time soil side corrosion patches were detected in north east portion of the tank and several holes were identified in that region during scanning.

Tank was put back in service after removing the effected sketch plates and replacing them with the new plates.

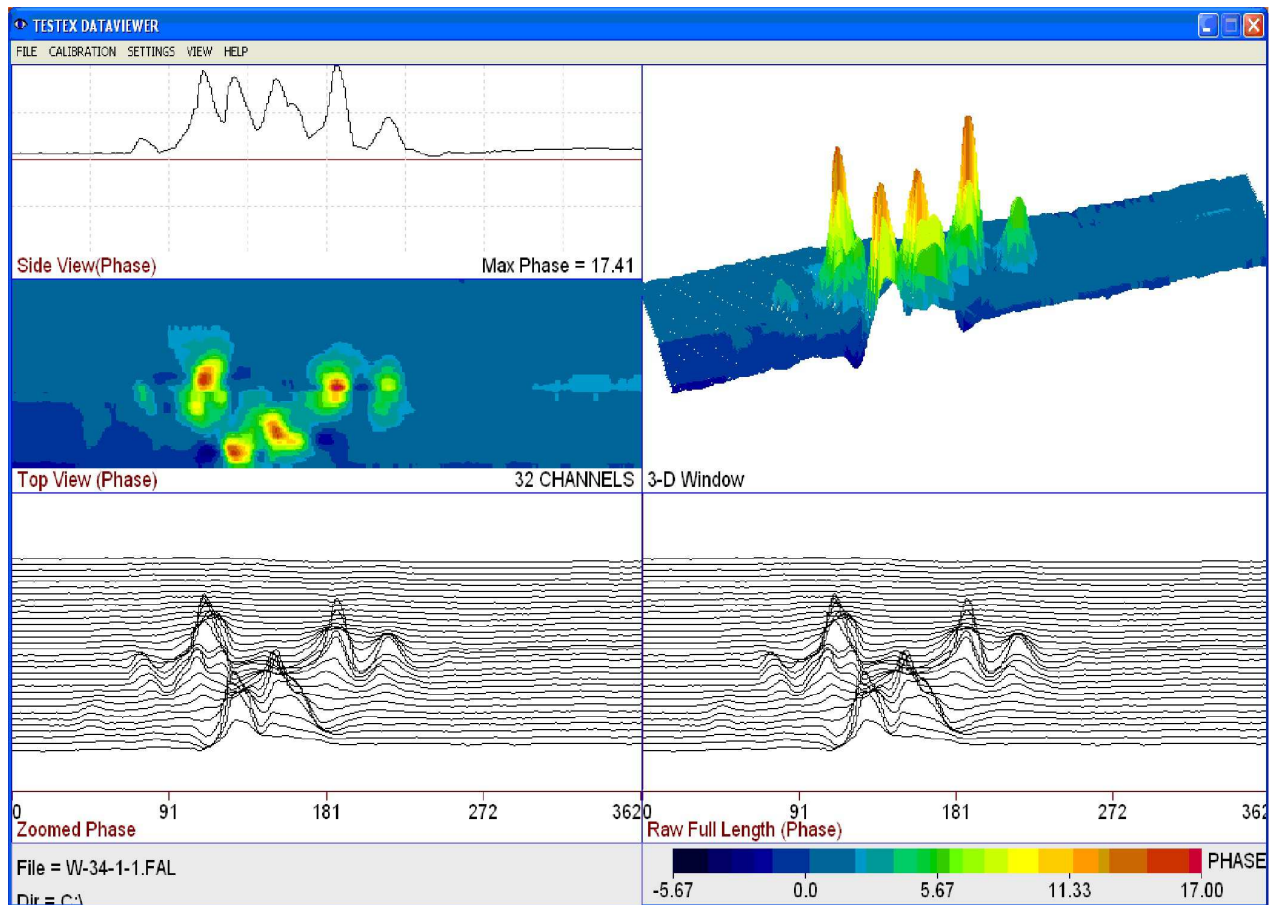
*Sketch Plate # 34, Showing Underside Corrosion Min. UT reading 4.8 mm.*

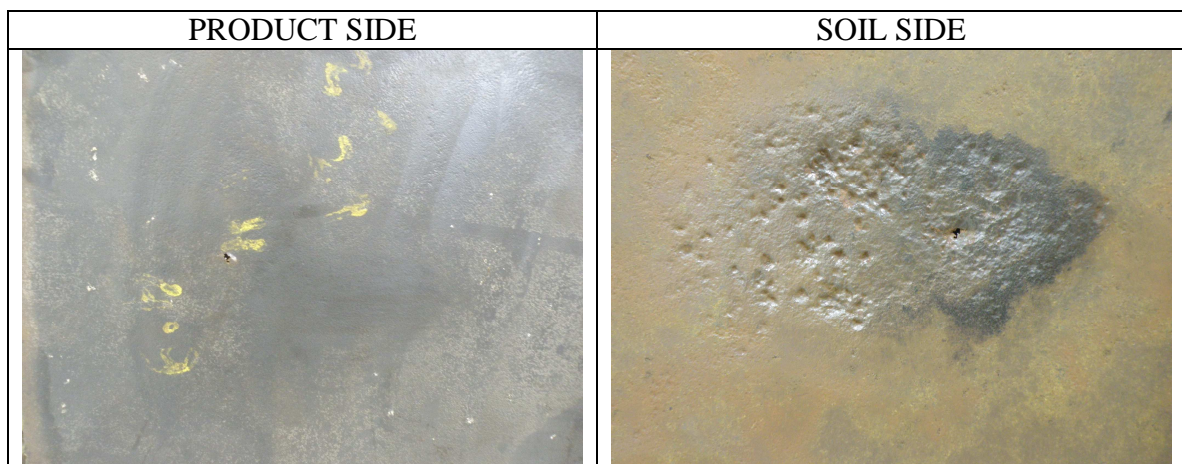
Photos of Sketch Plate # 34, showing product and soil side.

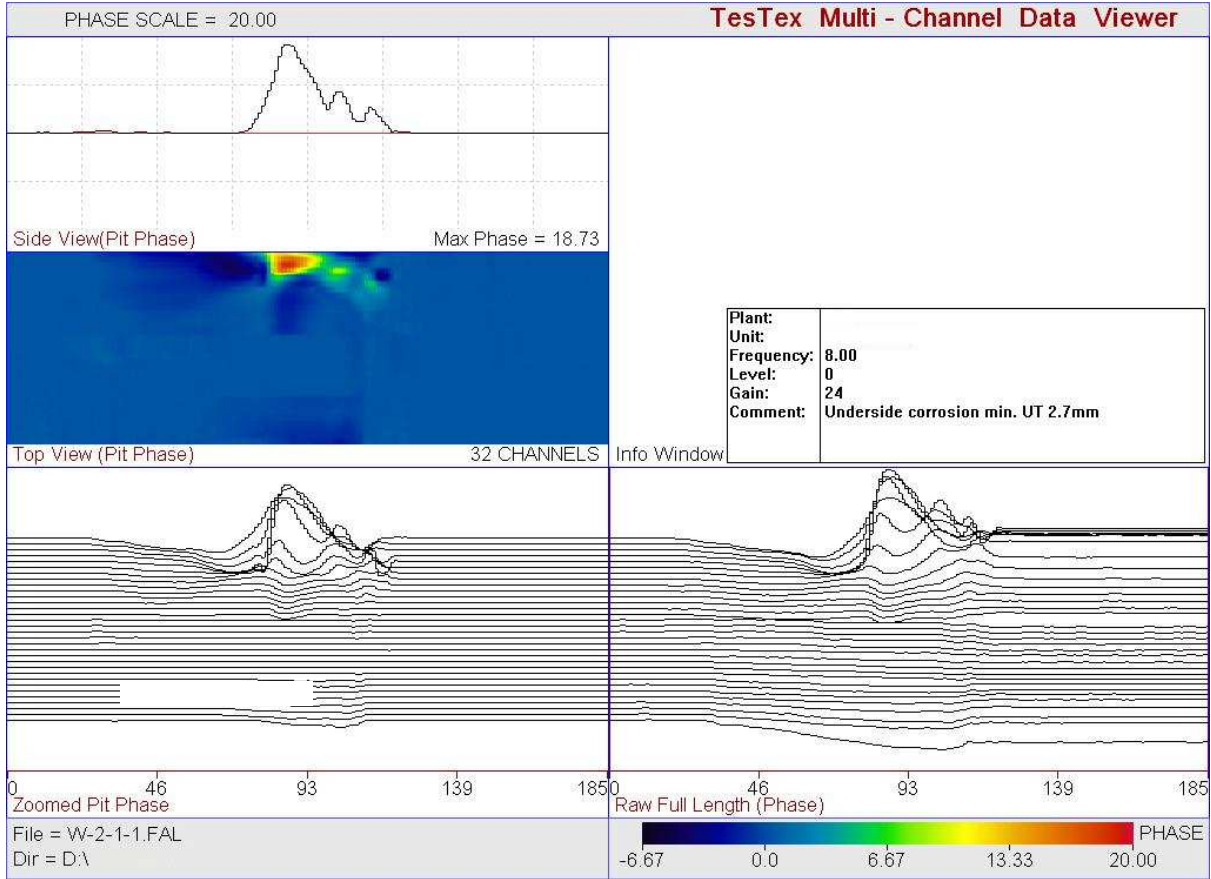
*Annular Plate # 2 Showing Underside Corrosion Min. UT: 2.7mm*

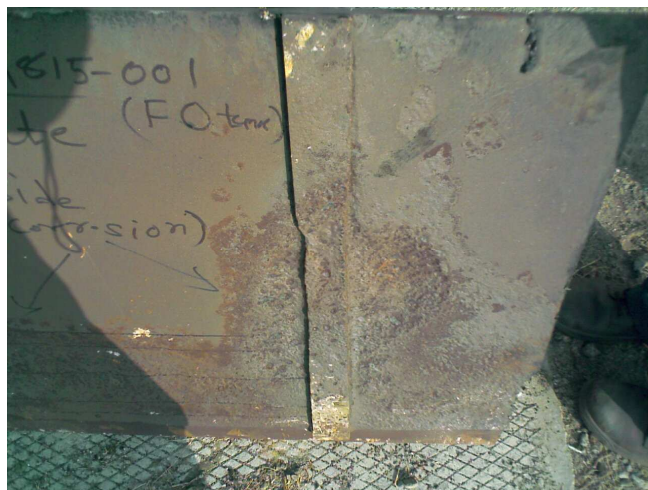
Soil Side Corrosion

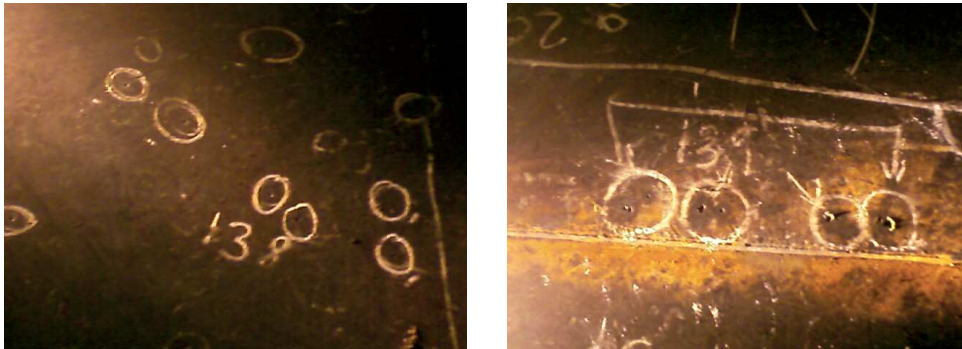
### Soil side corrosion leading to pinholes from Product side
