Case Study

Inspection of Utility Boiler Furnace Wall Tubes using Low Frequency Electromagnetic Technique (LFET)

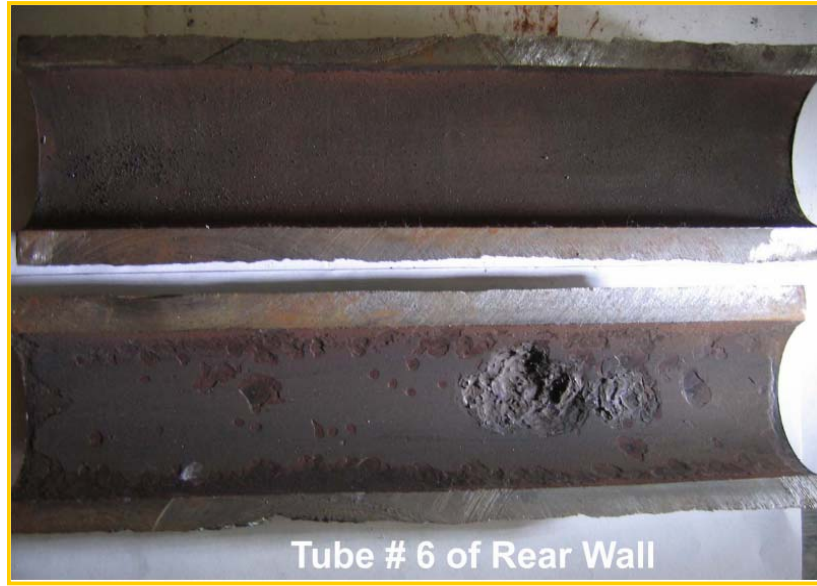
3 locations were having isolated internal corrosion more than 50% of the tube thickness and two locations were having internal corrosion of 18% at 0 to 2 Meters.
4 locations were having internal corrosion of 20% at 2 to 4 Meters.

2 locations were having isolated internal corrosion more than 50% at 0 to 2 Meters.
17 locations were having internal corrosion up to 22% at 2 to 4 Meters.

Tube showing Internal Corrosion Detected during LFET Scanning

Tube replacements can be made only in the effected localized areas in boiler instead of replacing the entire panels with out through survey.

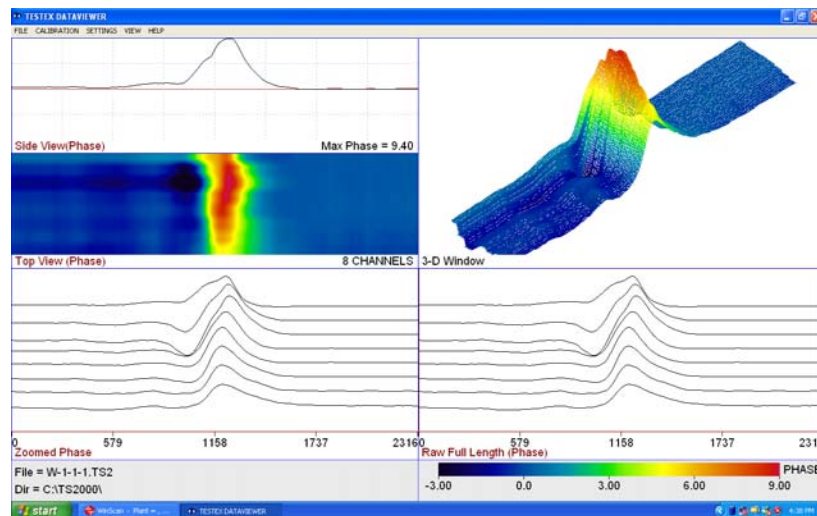
Waveform showing above tube location as observed during Scanning
