## Case Study

### Pipeline Scanning using Low Frequency Electromagnetic Technique (LFET)

Pipeline Scanning work was carried out by **TesTex** using **Low Frequency Electromagnetic Inspection** in December 2014 in one of the LPG Pipeline with **TesTex** make **LineCat System** to detect, locate and measure the extent of corrosion and pitting from top side as well as under side, if any in the Pipeline.

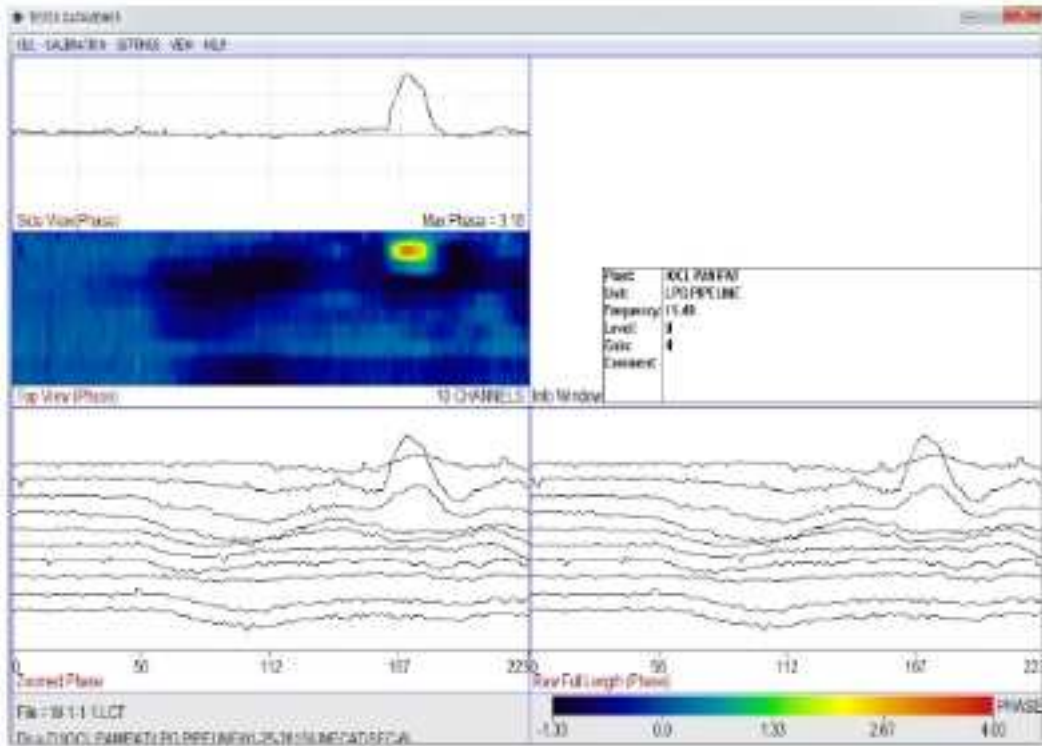
Above waveform shows Topside pit upto 3.3mm deep found on 2150.29 Mtr at 5:30 O'clock.

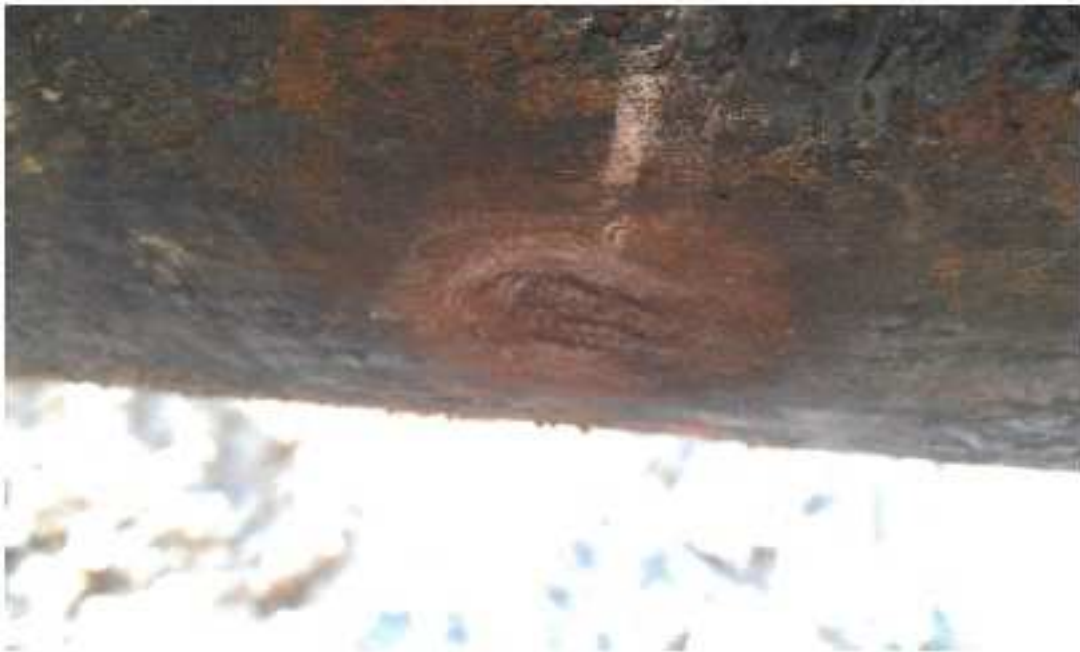
Above picture indicating Topside pit upto 3.3mm deep found on 2150.29 Mtr at 5:30 O'clock...

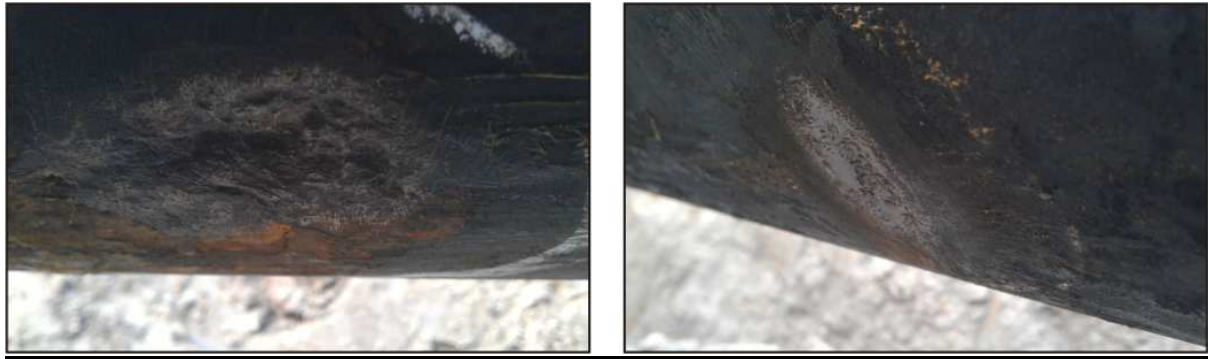
### Photographs Showing Defective areas in Pipes

Pipe was offered for scanning and **Low Frequency Electromagnetic Technique** was used. On scanning severe pitting patches were detected on the 6 O'clock position of the pipe. Further investigation confirmed tiny pits which were extending from the corrosion patched.

Pipeline was put back in service after removing the affected areas and replacing them with the new pipes.
