Case Study

Tubular Inspection using Direct Current (DC) Saturation Eddy Current Technique (MAGWAVE)

Inspection of Exchanger was carried out using Direct Current (DC) Saturation Eddy Current Technique (Magwave) to measure the Pitting/Corrosion of Exchanger Tubes.

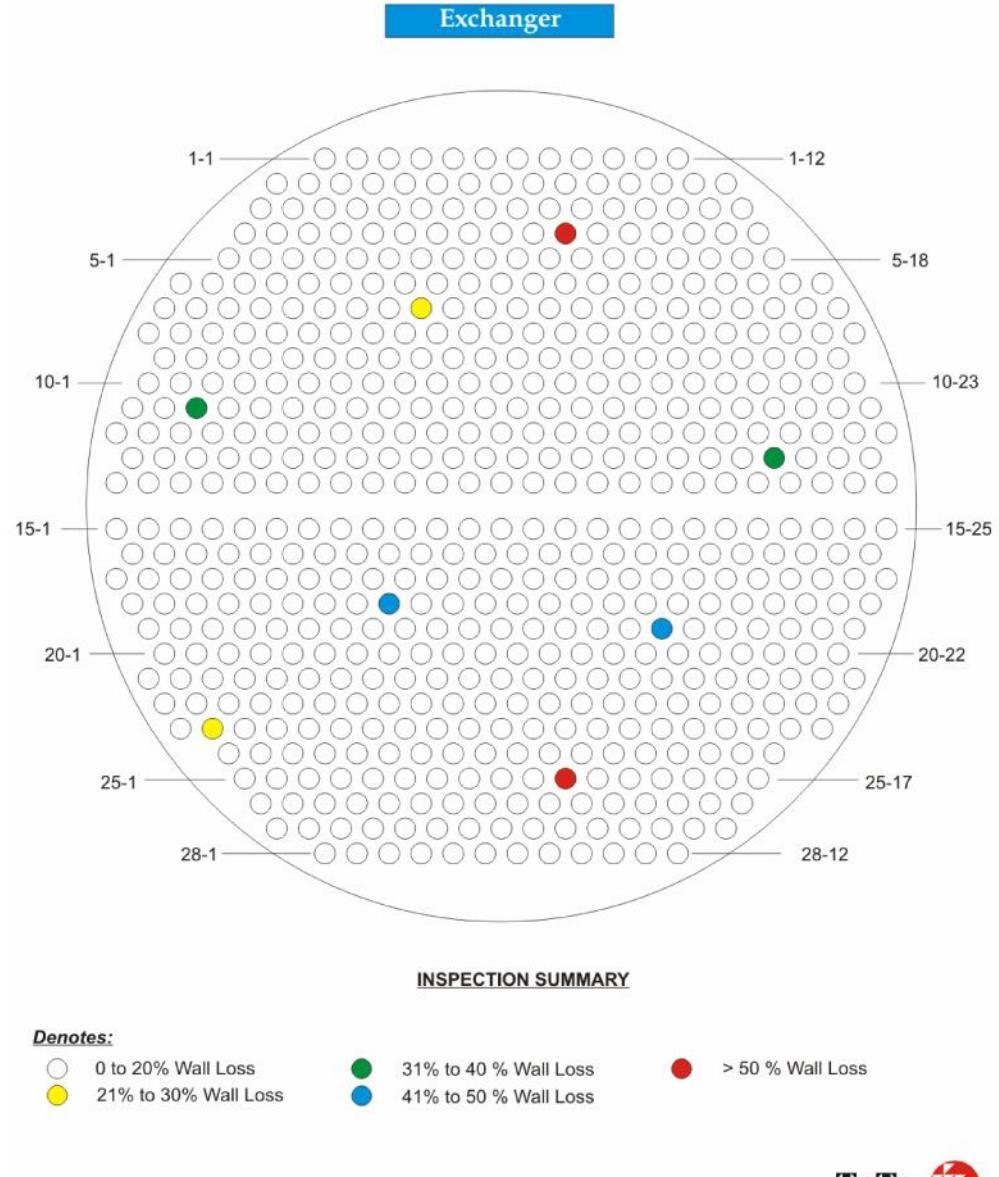
Color Coded Exchanger layout (Inspected in 2014

On Inspection it was observed that many tubes in the Exchanger were undergoing corrosion activity as shown in the diagram above and need further plugging. Client pulled out one tube and verified the results by split opening the tubes. When the results matched further plugging decision was taken.
