## **CASE STUDY**

### **Inspection of R. G. Boiler tubes using Remote Field Electromagnetic Technique (RFET)**

Tube Inspection of **R. G. Boiler (1206 A / B)** was carried out by TesTex NDT India Pvt. Ltd. in January 2009 with **EAGLE 2000 System** to detect, locate and measure the extent of Corrosion, Erosion if any at one of the Fertilizer plant in India.

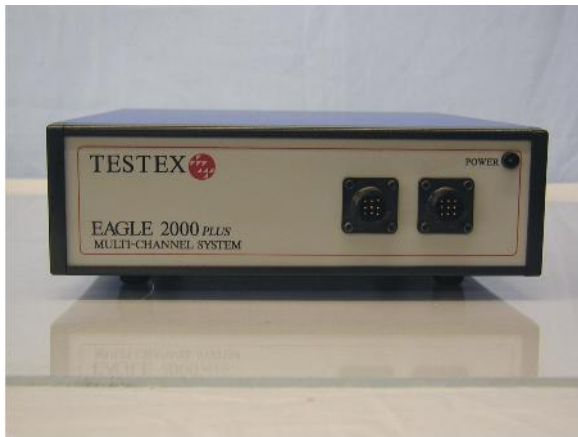
**Eagle 2000 Plus**

TesTex Inc. USA manufactured "**Eagle 2000 System**" uses **Remote Field Electromagnetic Technique (RFET)** which is based on the transmission of an electromagnetic field through the tube material. The exciter coil generates Eddy Currents at Low frequency in the circumferential direction. The electromagnetic field transmits through the thickness & travels on the outer diameter. A receiver coil that is placed in the remote field zone of the exciter picks up this field. In this zone, the wall current source dominates the primary field directly from the exciter. The separation between the two coils is between 2 to 3 times the tube OD. Since the magnetic field penetrates the tube wall twice, it will undergo a delay (phase lag) and attenuates (amplitude attenuation). The phase lag & amplitude attenuation incurred will depend on the local wall thickness & are measured. The measurement signal is displayed on a screen.

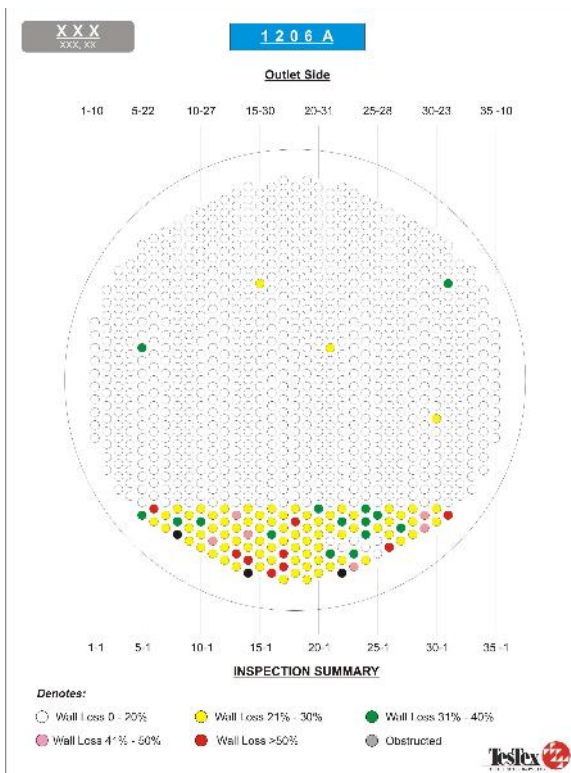
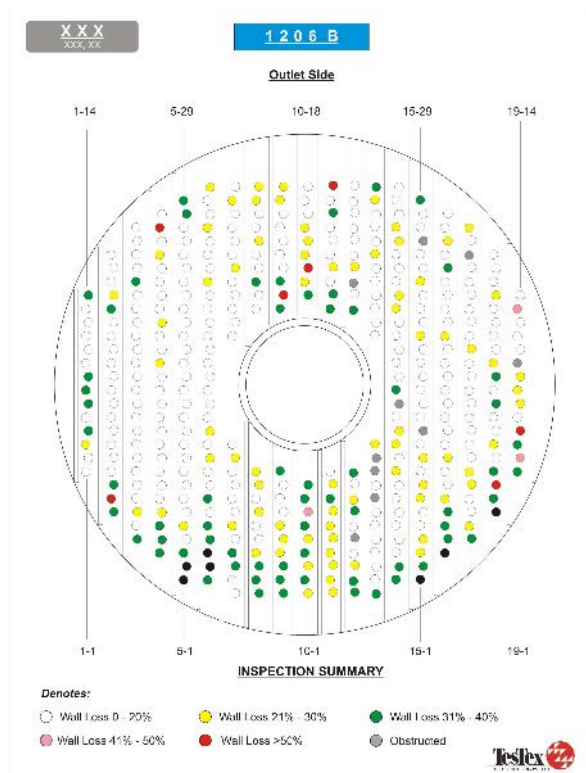
## Color Coded R. G. Boiler layout

On Inspection it was observed that many tubes in the RG Boiler were undergoing corrosion activity as shown in the diagram above and need further plugging. Before plugging client pulled out one tube and verified the results by split opening the tubes. When the results matched further plugging decision was taken.

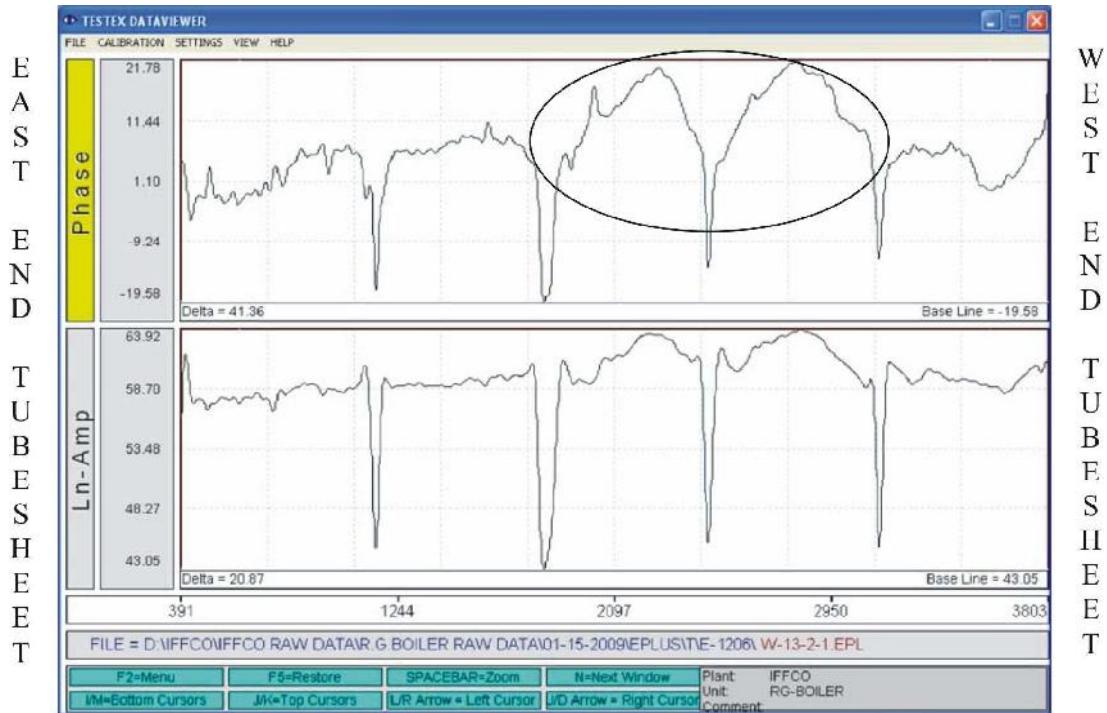
## R. G. Boiler # 1206 A

Above Waveform is of Row # 13, Tube # 2 showing Wall Loss > 50%.

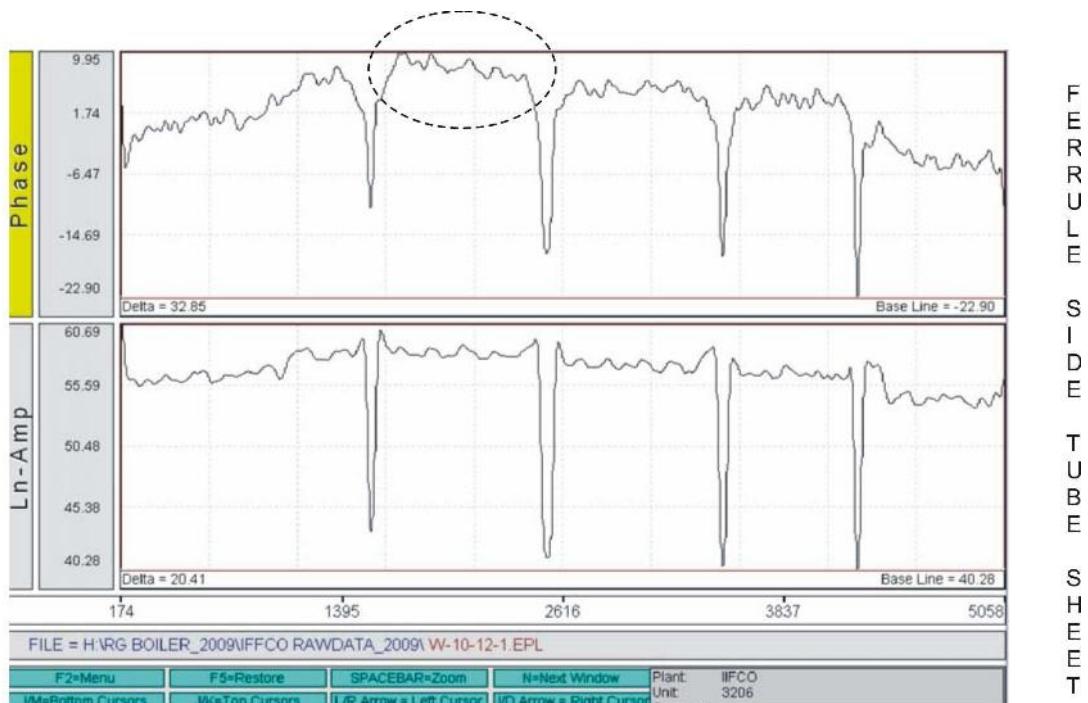
## R. G. Boiler # 1206 B

Above Waveform is of Row # 10, Tube # 12 showing Wall Loss > 50%.
