### Tubular Inspection using Internal Rotary Inspection System (IRIS)

Inspection of **R. G. Boiler** was carried out using **Internal Rotary Inspection System (IRIS)** to measure the thickness of Exchanger Tubes up to Ferrule area

The Inspection was carried out on June 2014.

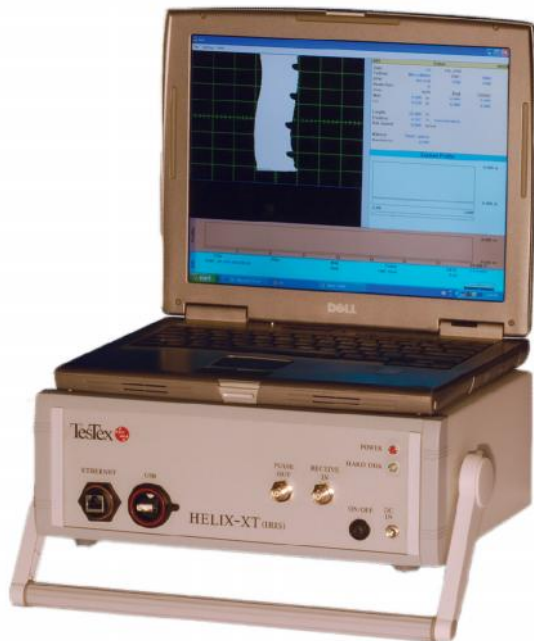
**Helix XT Electronic Box**

The Helix-XT system is an all-digital, microprocessor-controlled instrument. It contains all necessary electronics for collection and analysis of data using the IRIS inspection method.
